STATE FIRE MARSHAL'S OFFICE

Line of Duty Death Investigation

Investigation Number 03-194-01

Firefighter James Taylor

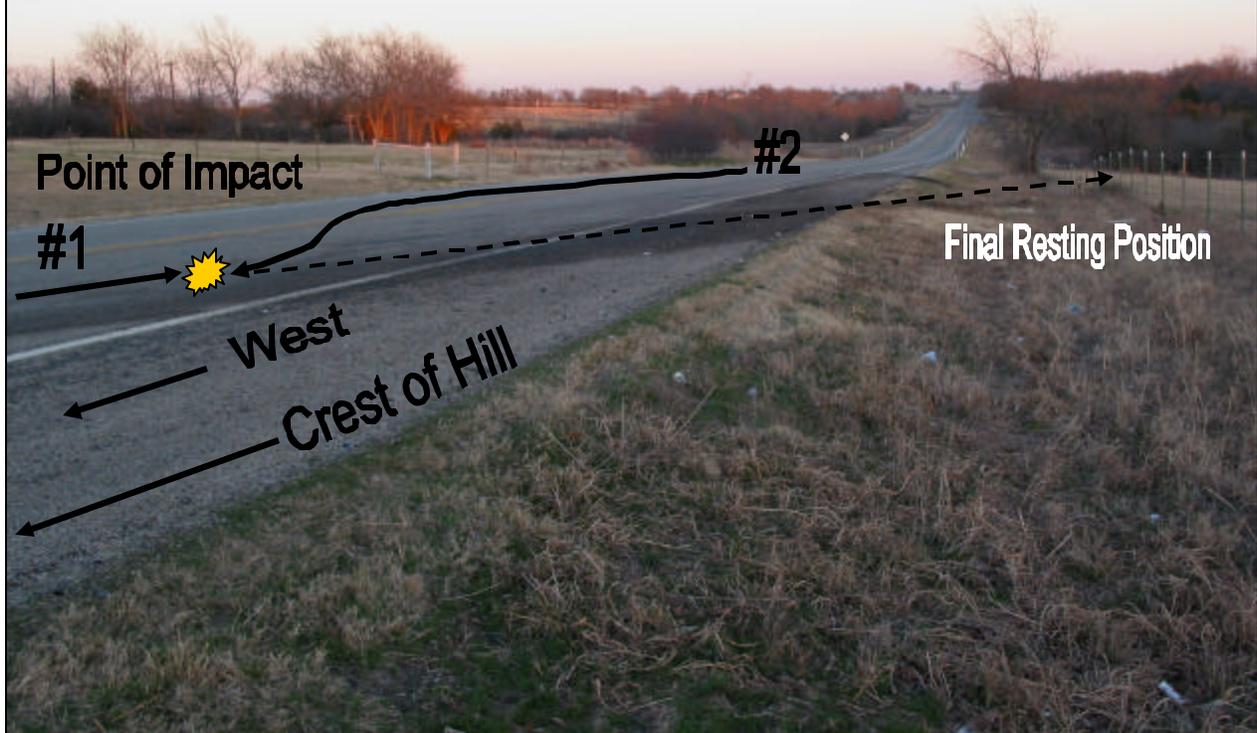
ACCIDENT SCENE-STATE HIGHWAY 56-FANNIN COUNTY, TX

After the collision, both vehicles came to rest on the grassy shoulder on the south side of SH 56. Vehicle #1 had damaged a barbed wire fence and came to rest facing southwest. Vehicle #2 came to rest approximately 75 feet from the rear of Vehicle #1 facing northeast. Both vehicles caught fire a short time after the impact. The fires were primarily concentrated in the engine compartment and front passenger areas.

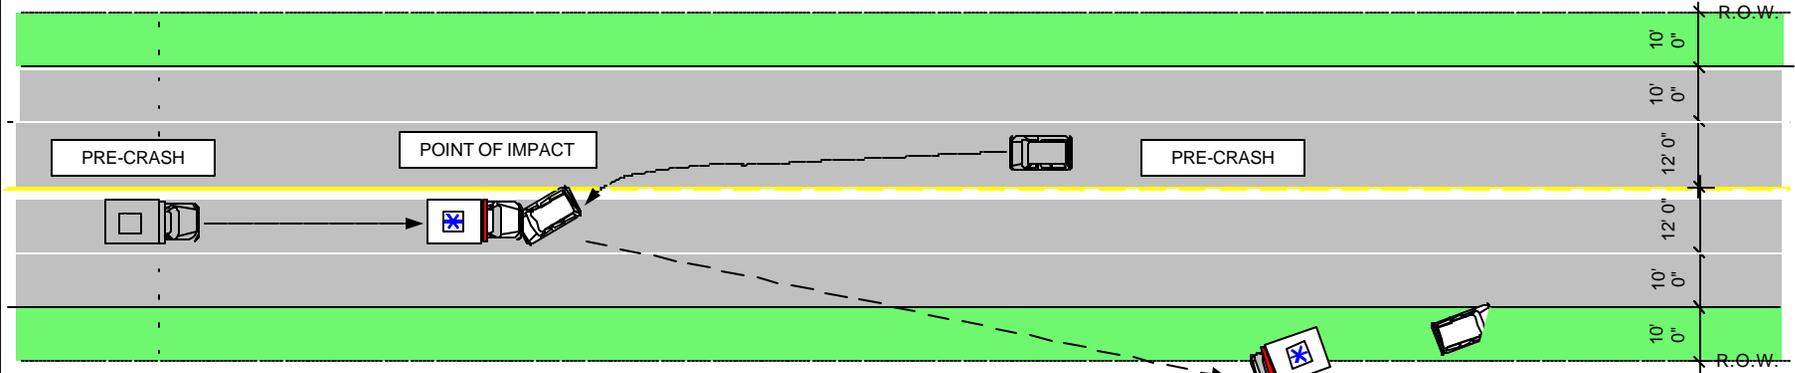
Texas Department of Public Safety (DPS) Trooper Kevin Verner and a DPS accident reconstruction team investigated the accident. Verner determined that Vehicle # 1, the Bonham Fire Department ambulance, was traveling eastbound on State Highway 56 (SH 56) with emergency warning equipment operating. Vehicle #2 was traveling westbound on SH 56. Vehicle #1 crested a hill and the driver observed Vehicle #2 swerve into the eastbound lane. The left front of Vehicle #2 struck the center front of Vehicle #1. There were no pre-crash skid marks from either of the vehicles. Vehicle #1 was traveling at approximately 60-65 MPH at the time of the accident with emergency warning lights and siren activated.

The incident occurred on a straight, moderately sloped section of SH 56. The roadway crests a hill just west of the accident scene. The posted speed limit in the area is 65 MPH.

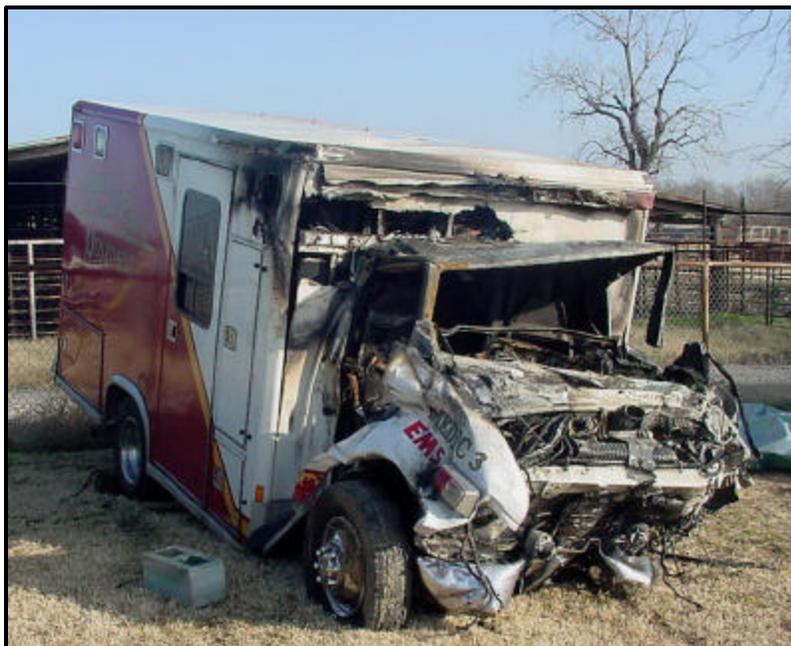
The gross vehicle weight listed for the vehicle was 10,500 pounds. The Texas Department of Public Safety weighed the vehicle after the accident and found that it weighed 11,800 pounds without crew or patients. It was not possible to determine the total mileage on the vehicle because of fire damage, but fire department records show Medic 3 had 312,657 total miles shortly before the accident in January 2003.

The engine and transmission were replaced in July and August 2002, respectively. The vehicle underwent modifications based on Ford factory recall # 98S08 on August 12, 2002. The recall was because of fuel line chafing in similar vehicles which could cause a fuel leak or fire.

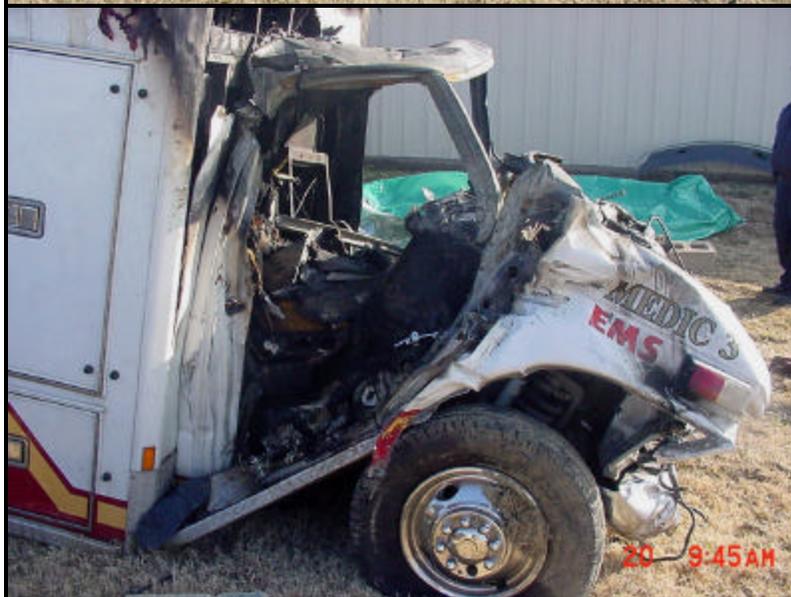
There was significant deformation of the vehicle and intrusion into the passenger space caused by the collision. The cab doors were removed with rescue tools when Taylor's body was removed from the vehicle. Other than fire damage, there was not significant damage to the ambulance box assembly.
